Date NOVEMBER 1981

Distribution No. 900-771-138UK

MODEL 900

Subject: DANGER OF OVERTIGHTENING WHEEL NUTS
AND REVIEW OF WHEEL NUTS NOW USED

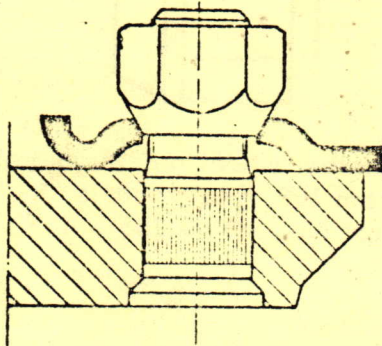
Position of wheel nut in new wheel

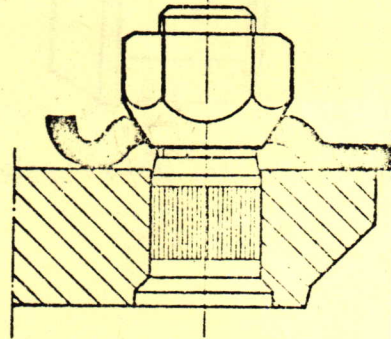
Limit of permissible wear using new wheel nut

If the wheel nut protrudes too far through the wheel due to over-tightening or wear of the wheel nut/wheel conical seat, cracks can form in the body of the wheel.

Torque wheel nuts to 64-73ft lbs.

Do not use impact wrenches.
