Utfärdare  
Issued by **AFTPT Bertil Gustafsson**Datum  
Date **April 1979**

**NOISE FROM REAR SHOCK ABSORBER**

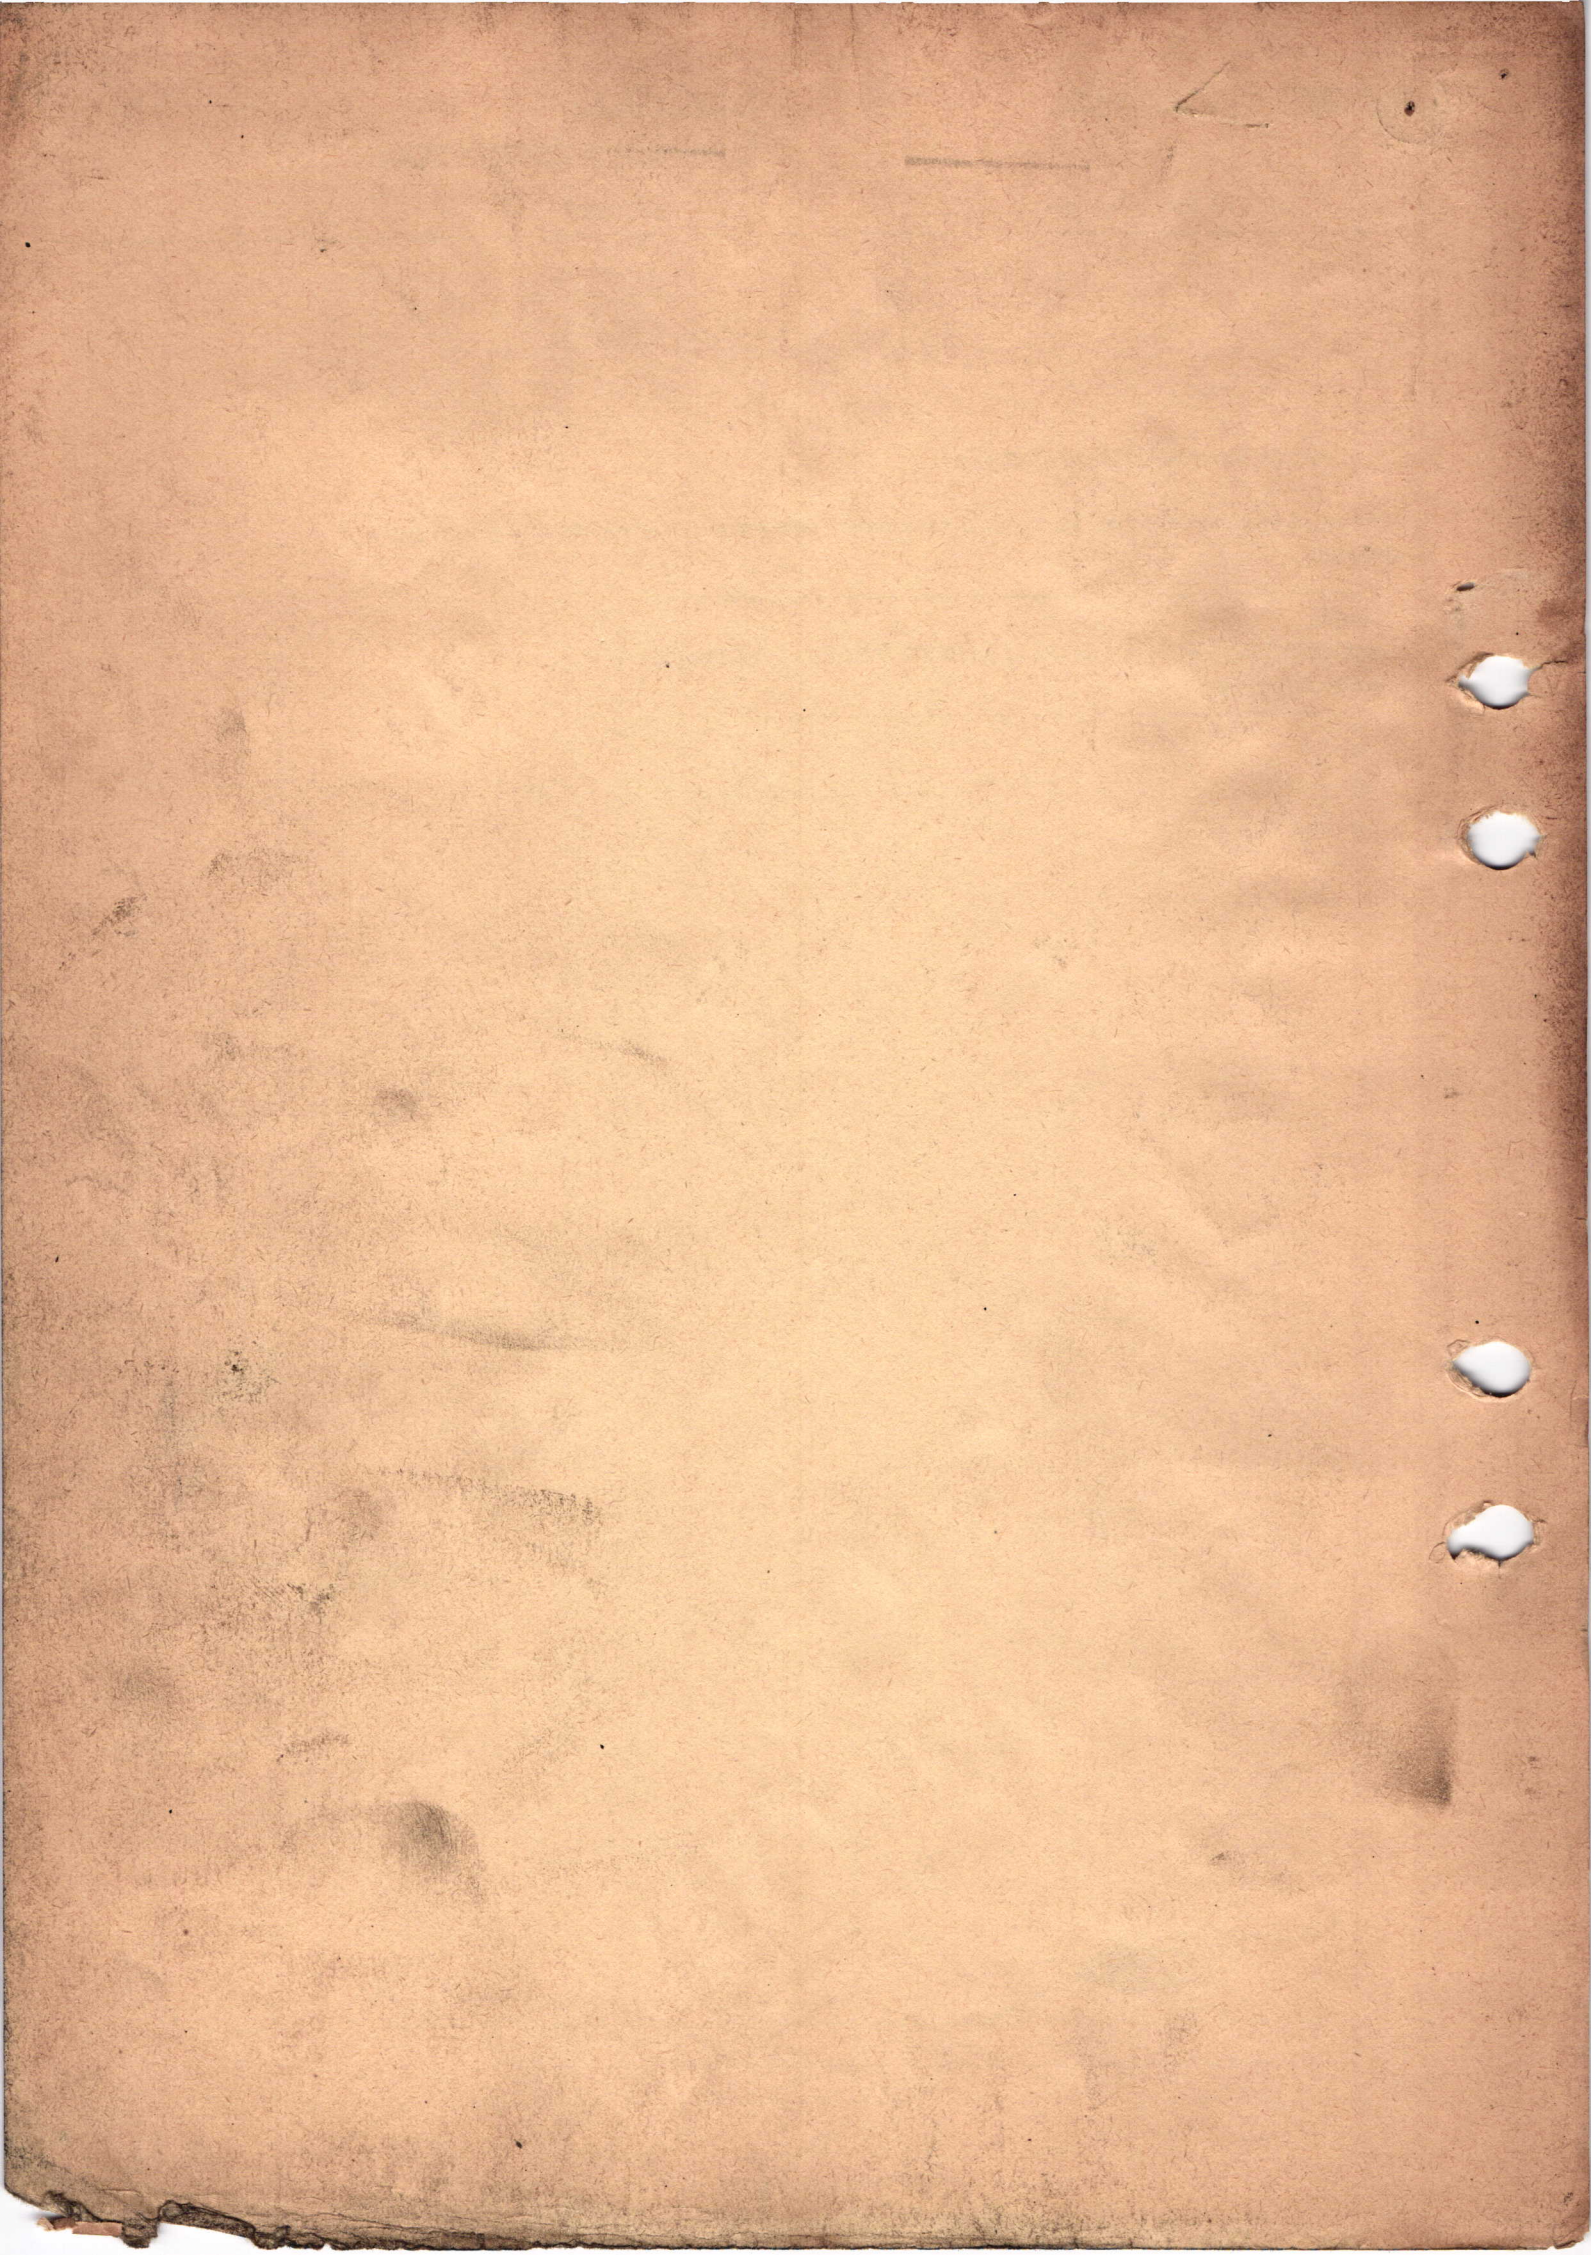
In the event of noise from the rear shock absorbers first check that the lower mounting is properly tightened.

Torque, rear shock absorber, lower mounting	95 ± 5 Nm (70 ± 4 ft.lb., 9.5 ± 0.5 kpm)
---	--
