Date
NOVEMBER, 1983

Distribution No.
900-771-280UK

900 MODEL: SUBJECT: SPACE SAVER SPARE WHEEL -
 POSSIBILITY OF INCORRECT INFLATION
 PRESSURE MARKINGS ON SIDEWALLS

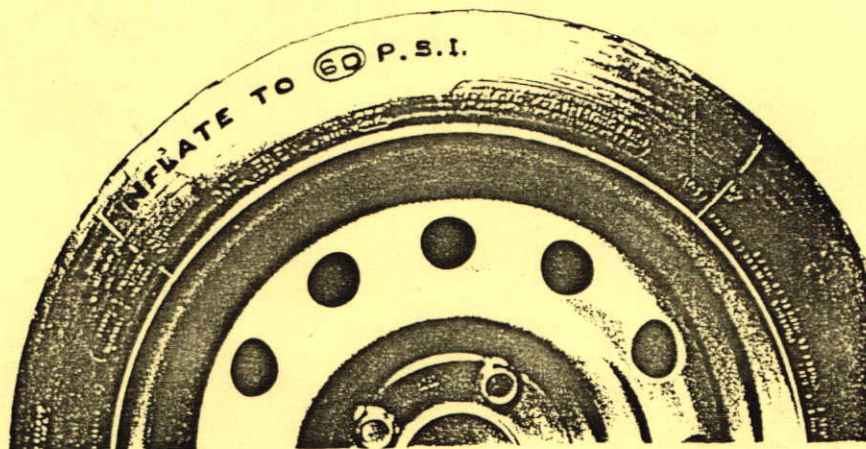
We are aware that some space saver spare wheels (Michelin T95/110R15) have been fitted in production that were intended for a different car and market and hence were marked "inflate to 60 p.s.i." on the sidewall. Otherwise the tyre is identical to the ones normally used.

The correct inflation pressure is 78 p.s.i. for use on Saab cars, and to avoid confusion by owners in possession of tyres with 60 p.s.i. markings, it is necessary to identify these tyres and remove the incorrect tyre pressure figure.

At the first available opportunity, check all Model 83 900's that come into the workshop. The spare tyre should not be marked with an inflation pressure on the sidewall - if you come across a tyre with a 60 p.s.i. marking as on the diagram, this must be erased as follows:-

PROCEDURE FOR REMOVING "60" MARKING FROM T95/110R15
TEMPORARY SPARE TYRE.

1. Remove from the car and place the inflated wheel and tyre on a clean work bench.
2. Take a $\frac{1}{4}$ sheet of 80 grit wet and dry paper and fold it over twice at approx $\frac{1}{3}$ rd of its width. Use this to "file" off the "60" figure in the "inflate to 60 p.s.i." marking until it just disappears.
3. Do not use excessive force and remove the absolute minimum of rubber.

Repeat the procedure on the other side of the tyre.

4. Inflate the tyre to 78 p.s.i. and replace in the spare wheel compartment.
