Swede Tooth

Saabs and Volvos have always stood out from the crowd with their distinctive styling and sometimes unique mechanical designs. But once you become familiar with a few of the quirks and oddities common to the two, you'll find a number of profitable repairs which will help "Sweden" your bottom line.

This month's Swedish Service Sampler will deal with assorted problems and repair tips which apply to both Saabs and Volvos.

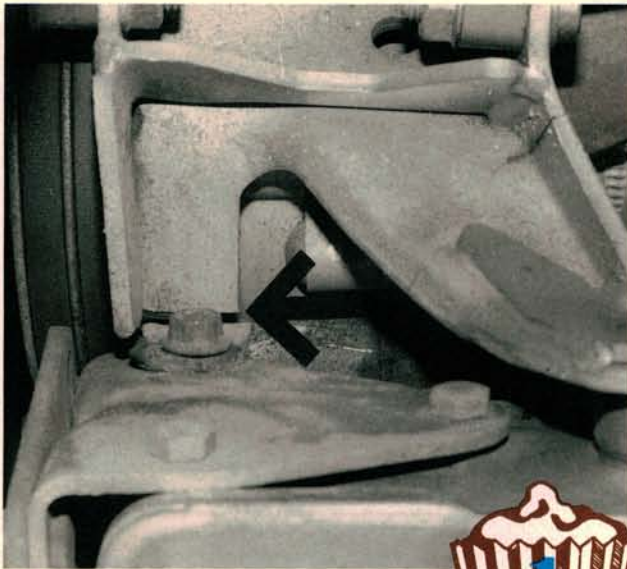
If you get a nasty vibration with the air conditioner turned on in a Saab 900, check the condition of the A/C compressor bracket and the tightness of all attachment bolts. The brackets are plenty thick, but will crack from vibration as this one has done.

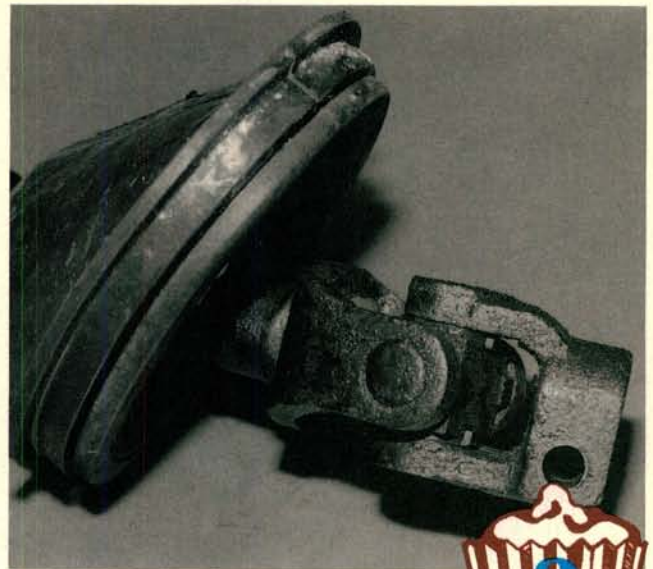
There are two universal joints in the Saab 900 steering column. The one outside the firewall can rust and bind over time and lead to "steering by Armstrong." Some steering racks have been mistakenly blamed and replaced before the real cause of the problem was discovered.

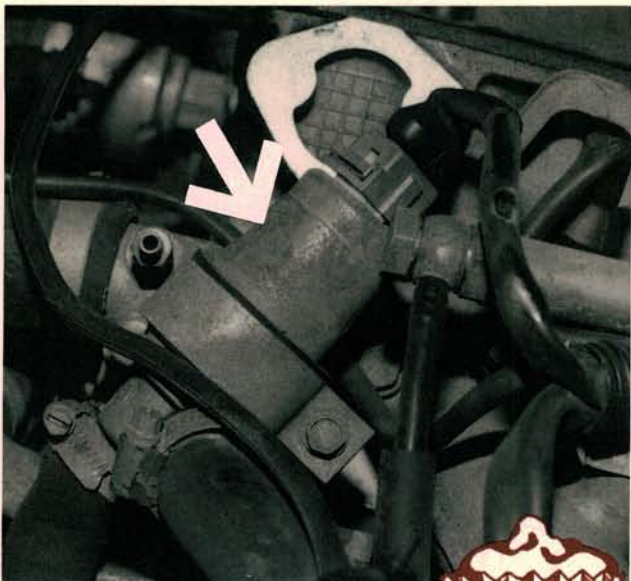
The idle on this Saab 900 hunts on occasion, and right now it's staying too high. It seems the idle stabilizer is varnished up and wants to stick. Tapping lightly on the housing "unsticks" it and our idle drops to its normal base setting. Our host shop replaces these on a regular basis.

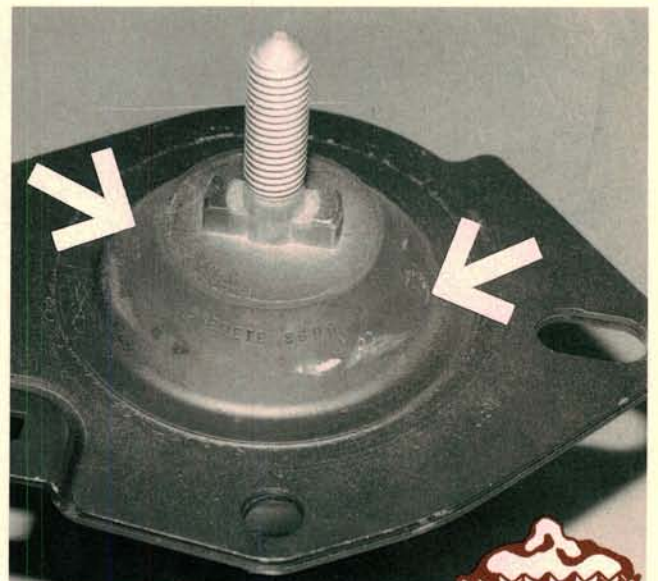
These newer style hydraulic Saab motor mounts are used on 9000s and late model 900s. They will fracture over time in the general area shown by our arrows and leak oil. A bad mount may be more noticeable in a 900 when drivetrain torque produces a noise, and causes excessive shifter movement.

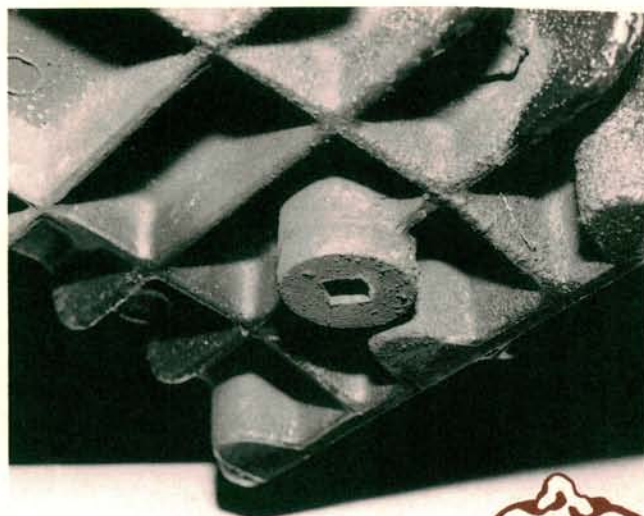
Saab

This is NOT the crankcase drain plug on a Saab. But some folks still insist on draining the differential instead of the crankcase during an oil change. The differential fries, even though the engine ends up plenty full. After all, the stuff coming out of the differential drain hole is engine oil, isn't it?

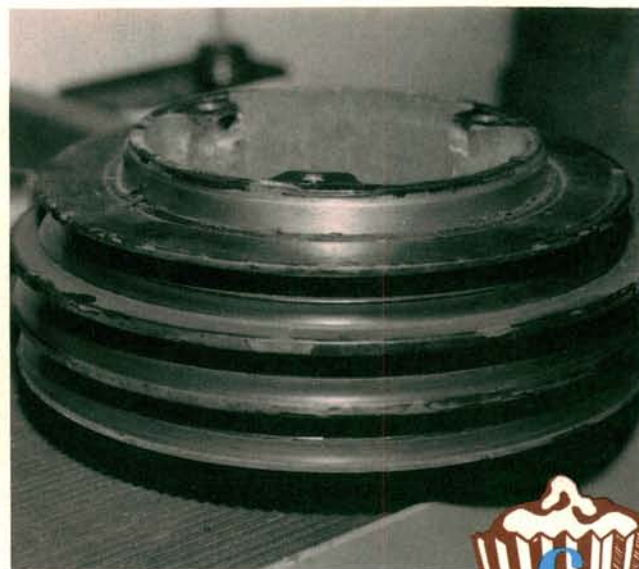
Harmonic balancers on Saab 900s are hidden down low, out of sight. If you hear a scraping or grinding noise from that area, check the balancer. The outer ring can separate from the rubber connecting it to the inner hub. Then it walks toward the engine until it starts grinding away at the front cover.

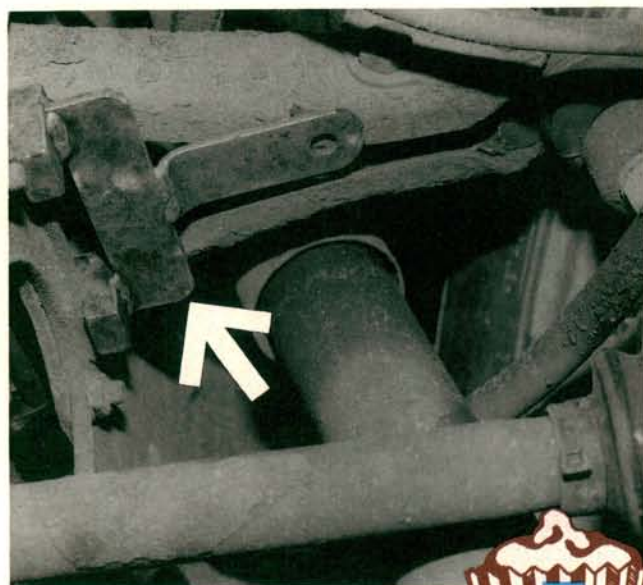
When checking the front suspension on a Saab 900, or replacing ball joints, insert this special tool (or equivalent) between the control arm and chassis. Otherwise the coil spring pushes the suspension all the way down, and you may not find a loose or worn part.

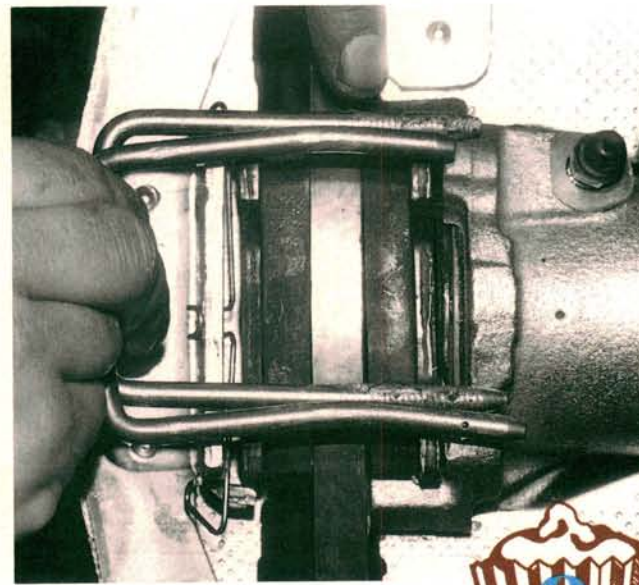
Caliper wear on Saab 900s can cause a loud clunk when braking in reverse. Replace the calipers and brake hardware, and put a slight downward bend in the brake pad retainer clips as shown. For a detailed explanation of this procedure, please refer to page 14 of the August 1988 issue of *Import Service*.

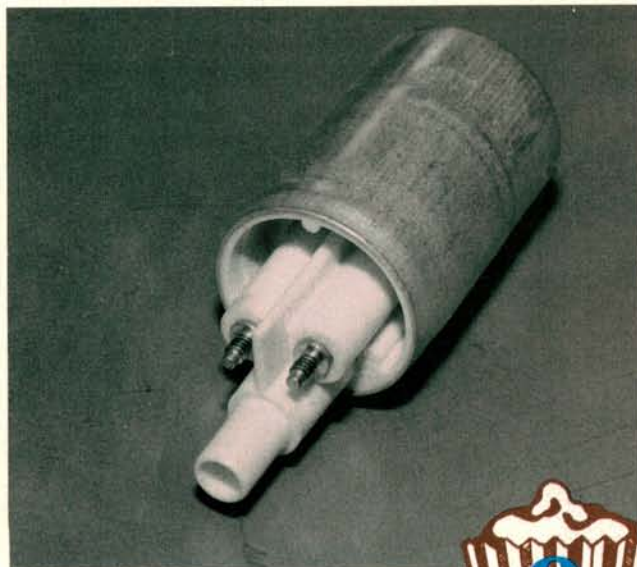
If a Saab or Volvo bucks or hesitates on acceleration, and the ignition system is okay, the prepump feeding the main fuel pump may be bad, starving the main pump. Volvo prepumps feed directly to the main pump. Saabs fill a chamber in the gas tank which feeds the main pump.

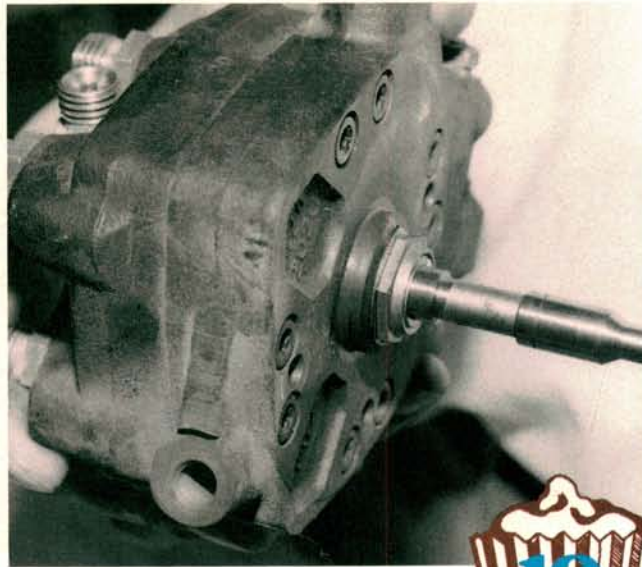
Saab or Volvo

Some K-Jet cars will intermittently refuse to restart after sitting for between 10 minutes and 2 hours. If rest pressure in the fuel system drops too quickly, and the fuel pump check valve is okay, the problem may be a faulty fuel distributor. Fuel may be leaking past the control plunger.

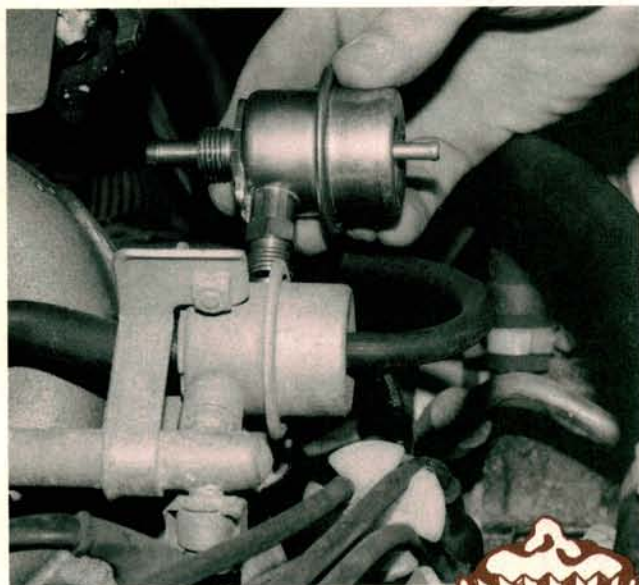
If the customer complains that his LH equipped Volvo starts hard cold, coughs black smoke, and has a fuel pump which growls like an unfed dog, check fuel pressure first thing. Stuck pressure regulators can send system pressure to the 100 PSI range, causing an extremely rich mixture.

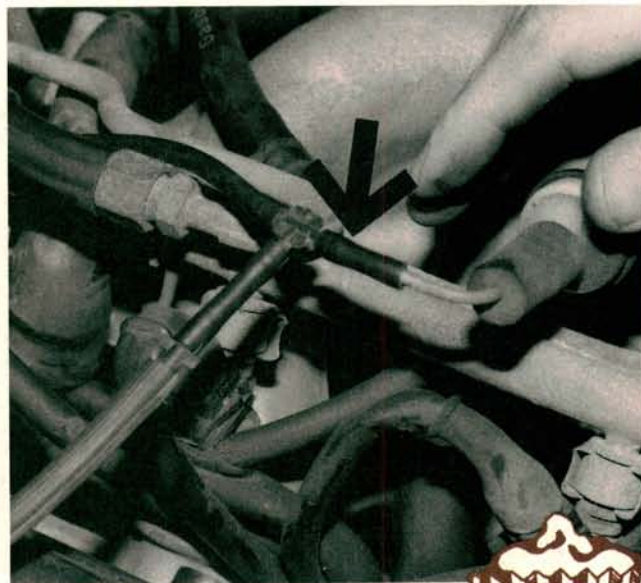
If your Volvo has a combined problem which seems to affect proper operation of both the cruise control and heater/defroster controls, check the vacuum hoses at the main vacuum source on the intake manifold. Cracks in dry hoses can cause leaks in the main vacuum source to both systems.

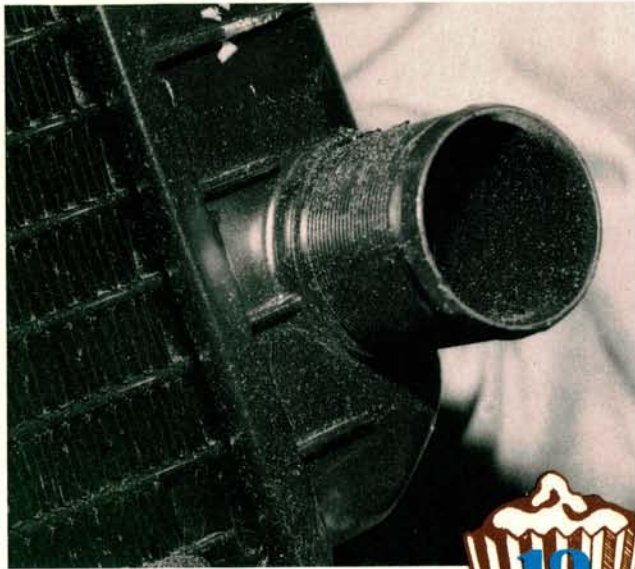
Volvo

Overheating problems on 1986 and newer Volvos can be caused by plugged radiators. The radiators are the aluminum/plastic variety, and the giveaway that it's plugged is a cold lower right hand corner of the radiator near the lower hose outlet.

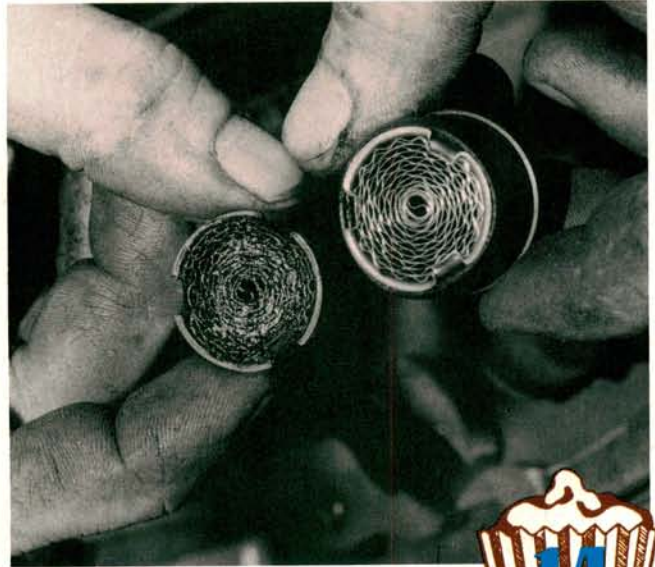
Volvo flame traps have been mentioned before in these pages. Acting as a crankcase breather restriction, they can get so plugged that the crankcase can't breathe. If your Volvo customer can't get the oil leaks stopped, it may be because crankcase pressure is forcing oil past seals and gaskets.

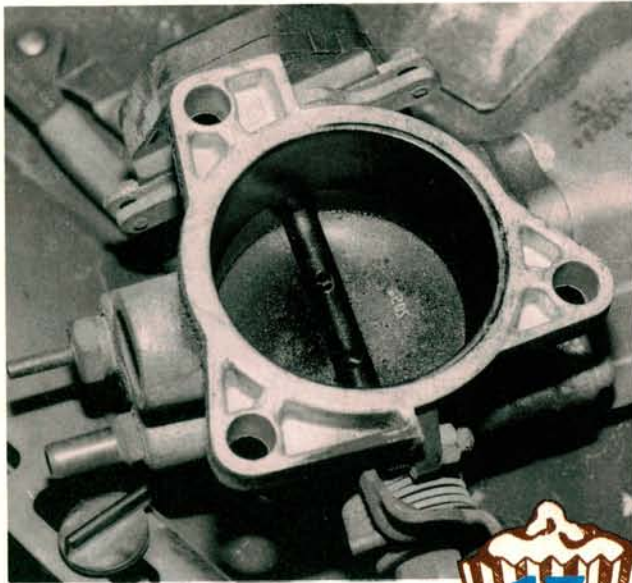
Volvo

A common cause of irregular idle and driveability problems on Volvos can be traced to carbon deposits which can interfere with normal throttle movement. The throttle can bind, which throws off the throttle switch adjustment. Clean with carb cleaner and check throttle switch adjustment when you're through.

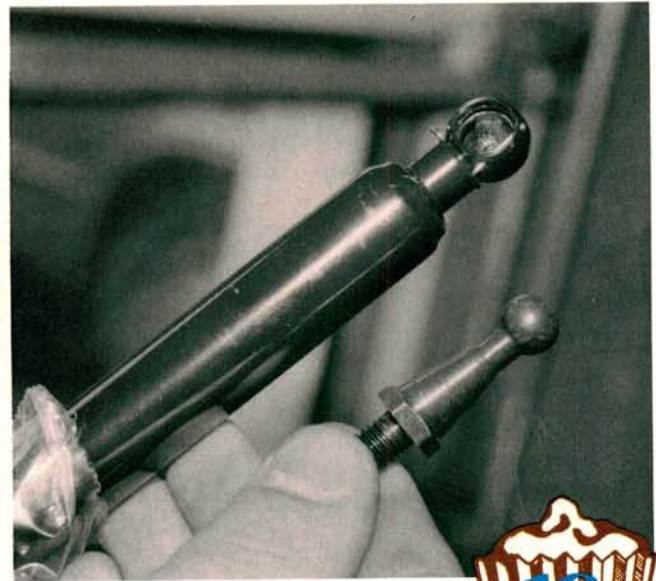
When replacing the tailgate supports on a 7-Series Volvo wagon, check the pivot studs at the base of the rod for wear. Some will wear to a point where they can pop off if someone lifts up on the hatch when it's already fully open. The new pivot studs screw into the body, and are easily replaced.

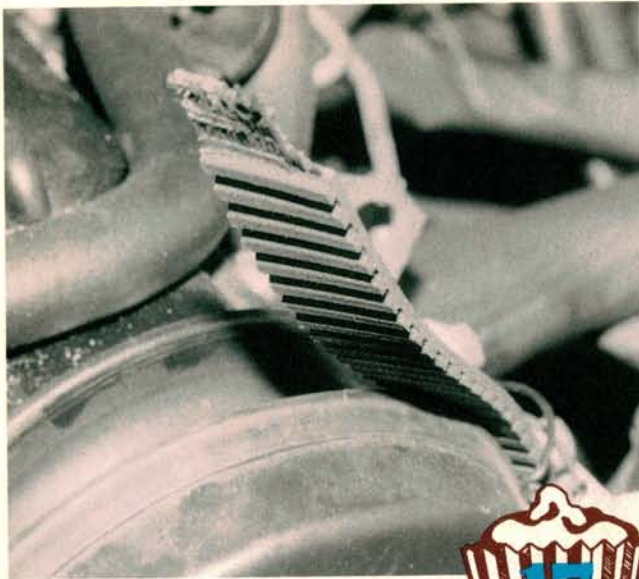
You say the owner of that Volvo diesel with 80,000 miles on it is reluctant to change the timing belt? Show him this photo and emphasize that this belt snapped at about 85 grand, laying waste to assorted internal engine components in a fraction of a second. The recommended interval is 75,000 miles.

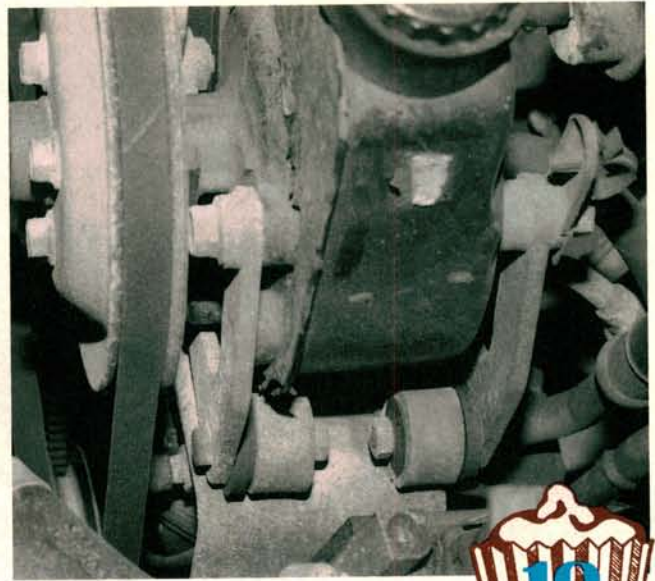
This Volvo power steering pump is mounted in rubber bushings. The pump housing moves on separate slides to adjust belt tension. When adjusting belt tension, make sure the pump pulley is perfectly parallel to the crank pulley when you tighten the bolts or you'll have belt noise and premature belt wear.

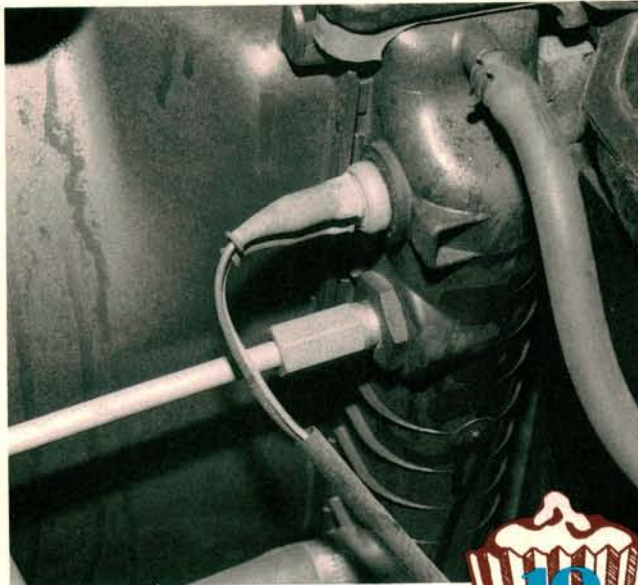
When the coolant gets hot on a Volvo 7-Series, the radiator thermo switch closes and turns on an electrical auxiliary fan. The closed switch also tells the computer to advance ignition timing. If base timing is adjusted when the switch is closed the ignition timing will be retarded when the switch opens.

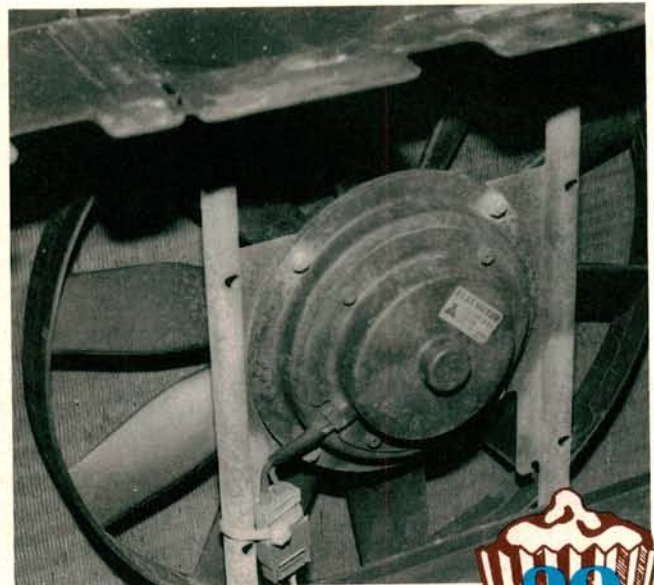
Volvo

Don't assume that the switch mentioned in the previous step is good just because the fan isn't running. Many of these fans are seizing and won't turn even when the switch closes. The fan on the very first car we checked was bad. By the way, the nut holding the fan to the motor is a left-hand thread.

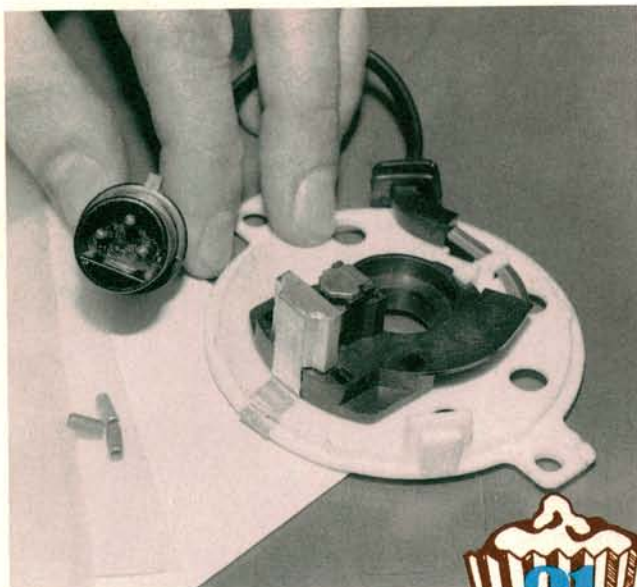
Some Volvos were equipped with Chrysler distributors. The pins on the Chrysler Hall generator are thinner than the mating connectors in the Volvo harness. Three spacers (arrow) must be installed on the pins to ensure a tight connection. If you replace a pickup make sure you install new spacers.

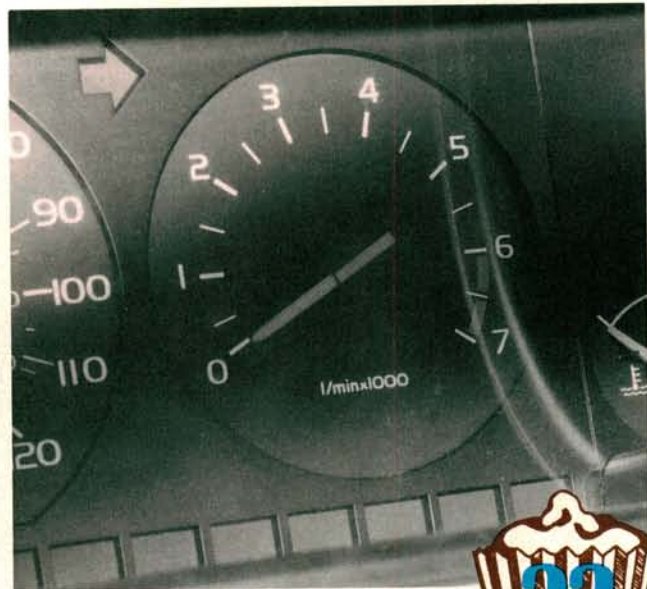
If you have a no-start caused by a no-spark on a Volvo Regina system, crank the engine and watch the dashboard tach. If the tach needle bounces, you know the ignition module, the distributor pickup, the coil primary circuit, and all related wiring are okay. The problem is in the secondary ignition circuit.

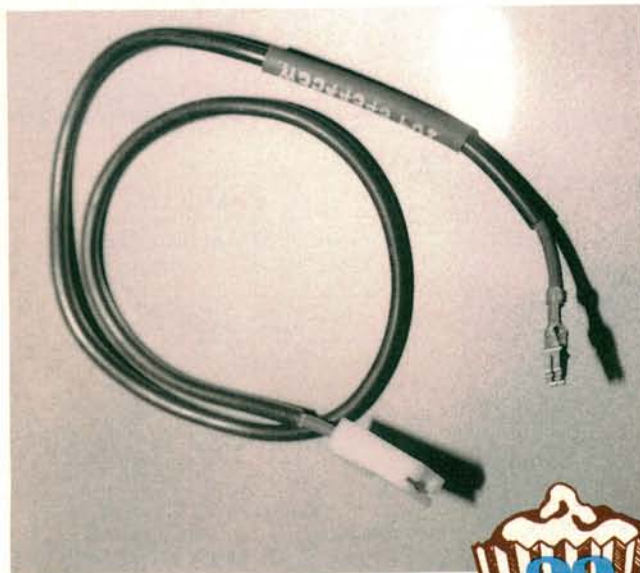
This patch harness can repair a Volvo 7-Series which starts but floods and stalls at temperatures below 25 degrees F. Remove the blue/green wire from the plug at the cold start injector. Snip off the end of the wire and insulate the bare end by taping back against the carside harness.

To Cold Start Injector

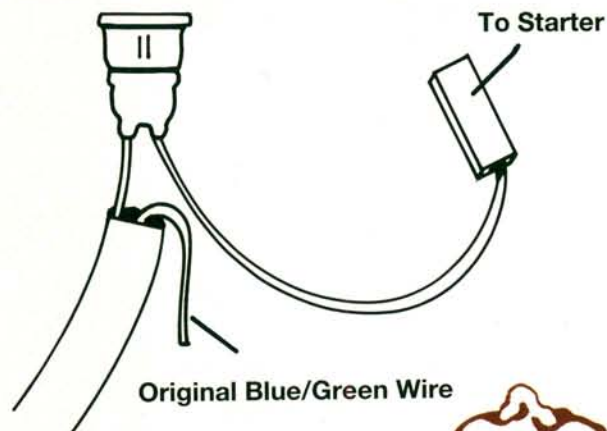
Volvo

Insert the metal wire connector in the plug to the cold start harness and plug it back onto the cold start injector. Take the insulated end of the harness and plug it onto the spare pin (15a or 16) at the starter solenoid. Now the injector will work only when the starter is cranked.
